## **Re: Reported high Lux levels within various HPT Kitchen areas**

Project: Cartwright Gardens

Date: 19<sup>th</sup> December 2019

Date/Time of survey: Wednesday 18<sup>th</sup> December 2019 @ 0900 Hours

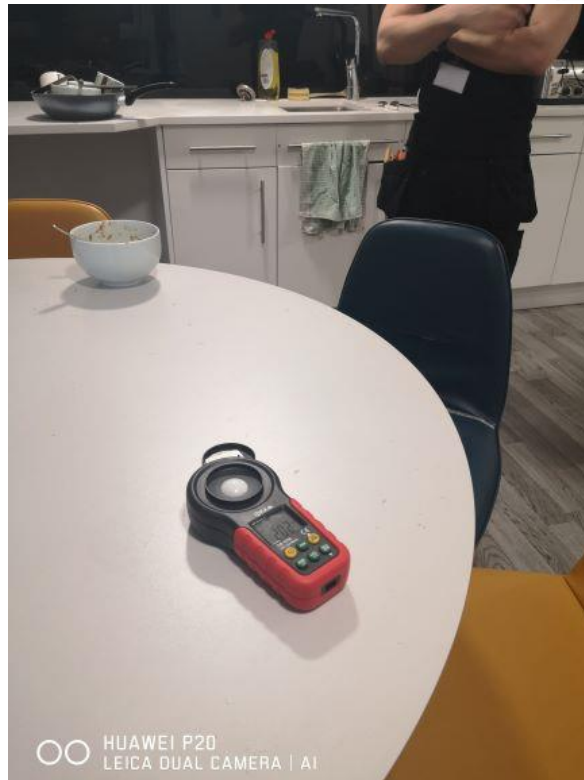
The first area is as per Fig 1 – Shows the set up for the level recording at table height. The Lux level in this location is shown in Fig 2 – 145.3 Lumens

Fig 1 – Ground floor Kitchen of HPT- Blinds drawn. 202 Lumens

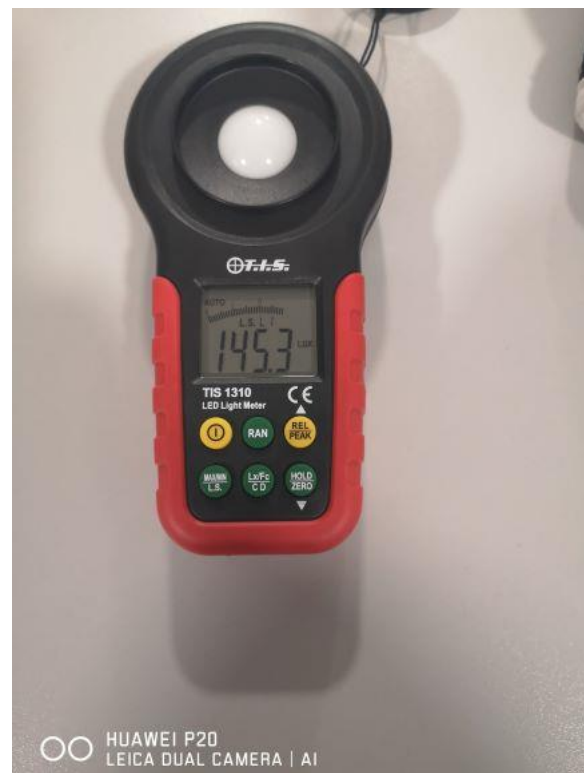
Fig 2 – Lux recording at table height ground floor kitchen of HPT is 145.3 Lumens

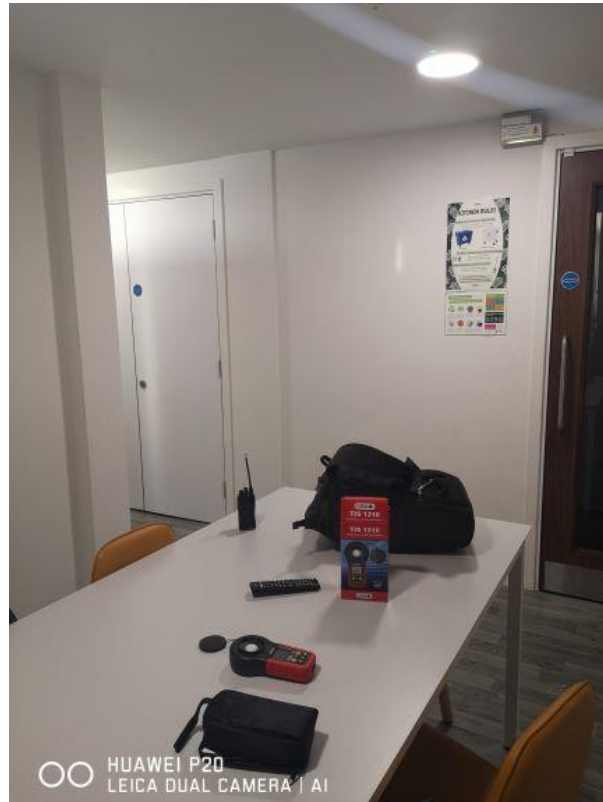
We reviewed next Fig 3 - 6 14<sup>th</sup> floor HPT kitchen. We looked at both the TV seating area and also the dining areas. Both of the areas do not offer any evidence of excessive light levels when blinds are drawn. The highest recorded value was in the dining area of the 14<sup>th</sup> floor but this reading of 254 Lumens is still acceptable.

*Fig. 3 showing the seating area layout on the 14<sup>th</sup> floor close to the TV area.*

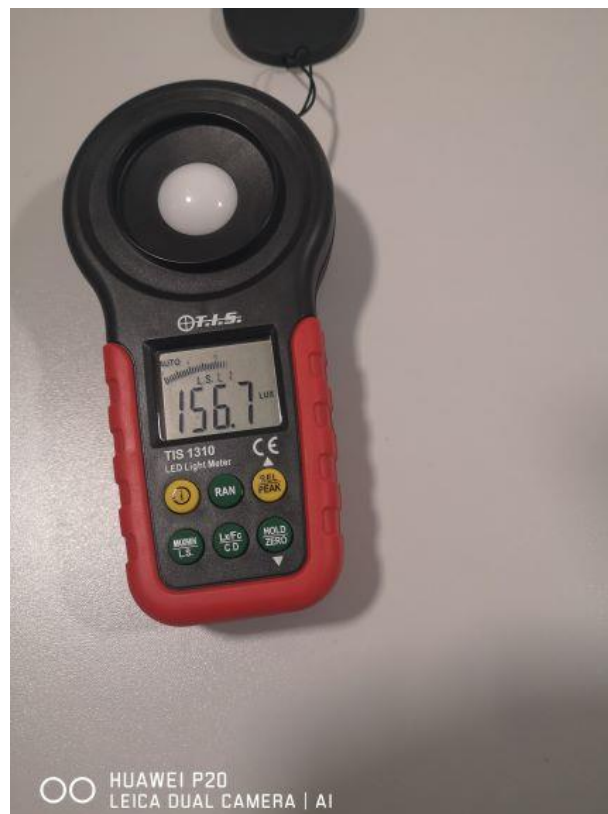
*Fig. 4 showing the recorded level in the TV area 14<sup>th</sup> floor, lux level 156.7 Lumens*

If it is declared that the areas are too bright for relaxing it is recommended that the fittings are replaced to give a better diffused light pattern (care must be taken in the design as there are guidelines for kitchens to ensure enough light to prevent risks). Or install of local isolation or dimming but this will offer a risk as to students leaving the lights on as they currently are PIR controlled.

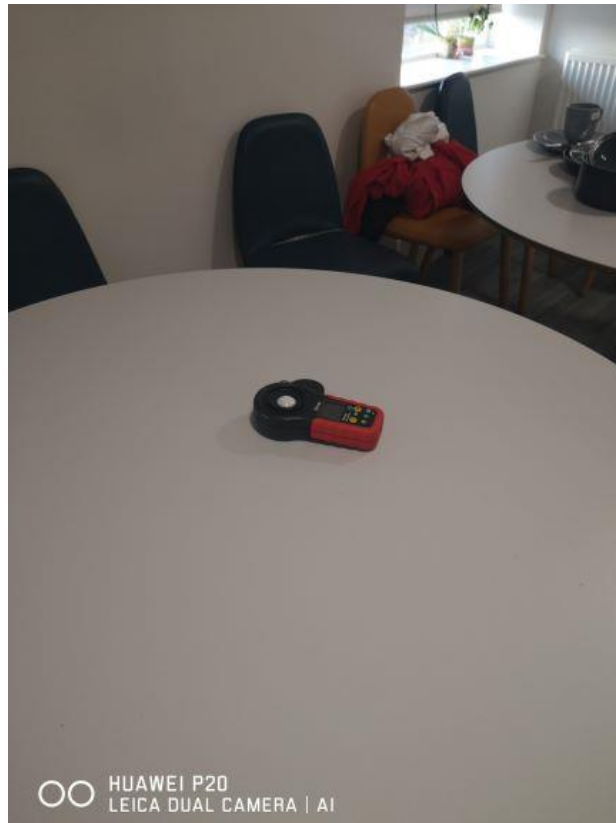
Fig. 5 showing the location for testing, 14<sup>th</sup> floor Kitchen dining area.

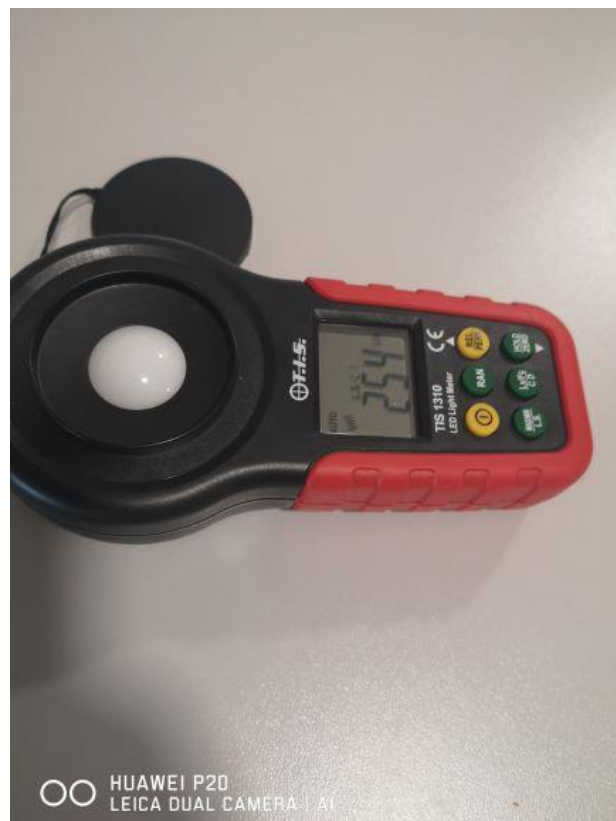
Fig.6 showing recorded Lumen in the dining area of HPT 14<sup>th</sup> floor kitchen

On the 14<sup>th</sup> floor there are signs of blue tac being applied to cover the lights with paper to reduce glare but this area was within the design specifications which show average of 200 Lumens for dining areas.
